Underground Water Distribution System Fort Belvoir, Virginia

Leak Detection Survey

CONTRACT #DACA01-94-D-0034
SYSTEMS CORP PROJECT #94013.09

August 1, 1995

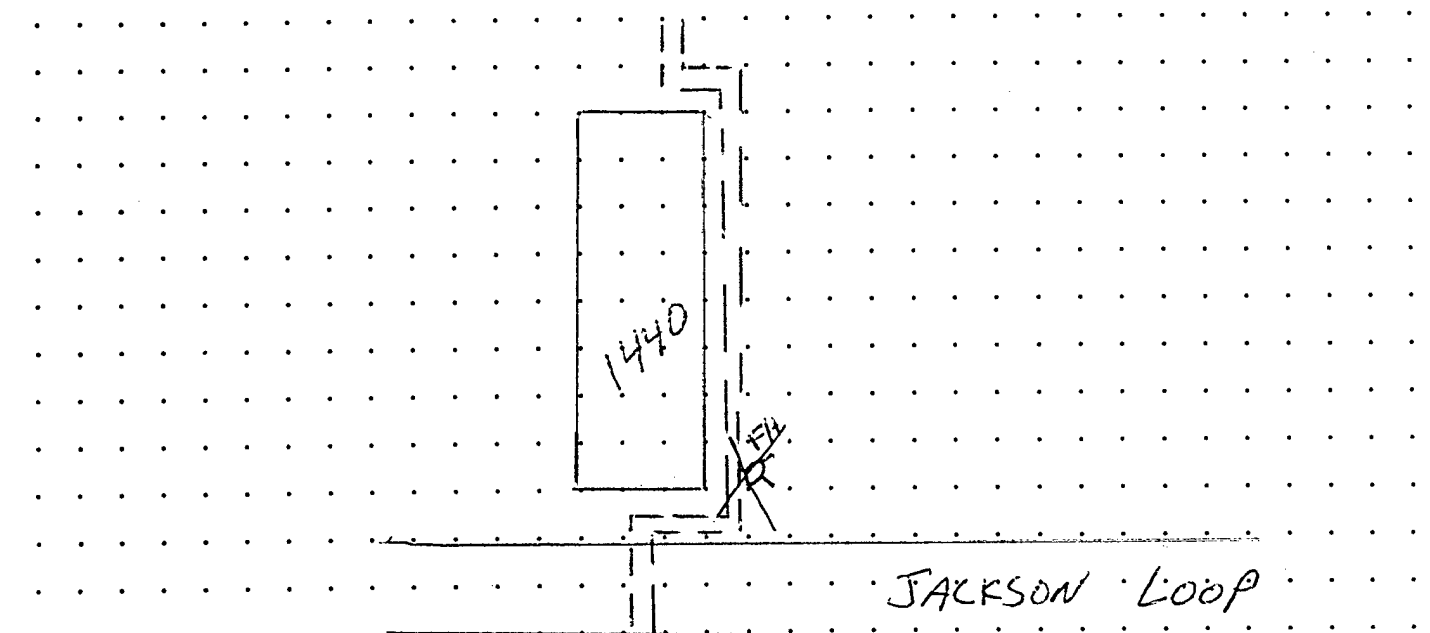
Page No. 1
Date 6-21-95
Ownership Public Private Easement
Leak Indication Classification
I(C) II(B) III(A)
(Circle One)

FINE hydrant in front of south side of
#1440 off JACKSON Loop leaking

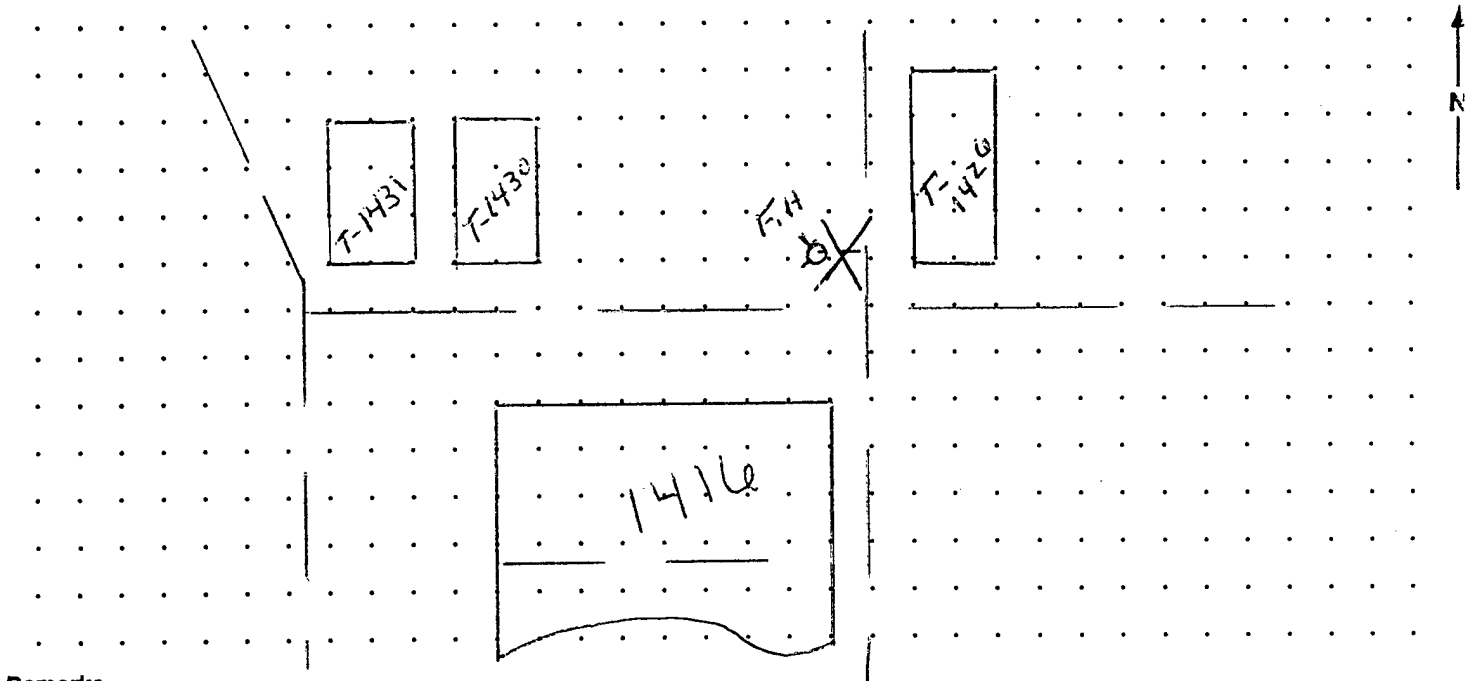
Page No. 2
Date 6-21-95
Ownership Public Private Easement
Leak Indication Classification
I(C) II(B) III(A)
(Circle One)

Fire hydrant at west side of Building T-1426
Leaking

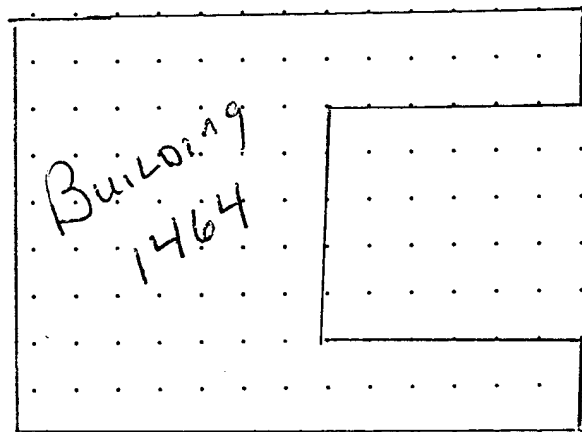
Page No. 4
Date 4-22-95
Ownership Public Private Easement
Leak Indication Classification
1 2 3
(Circle One)

FINE hydrant on EAST SIDE of Building #1464
Along HALL Road leaking

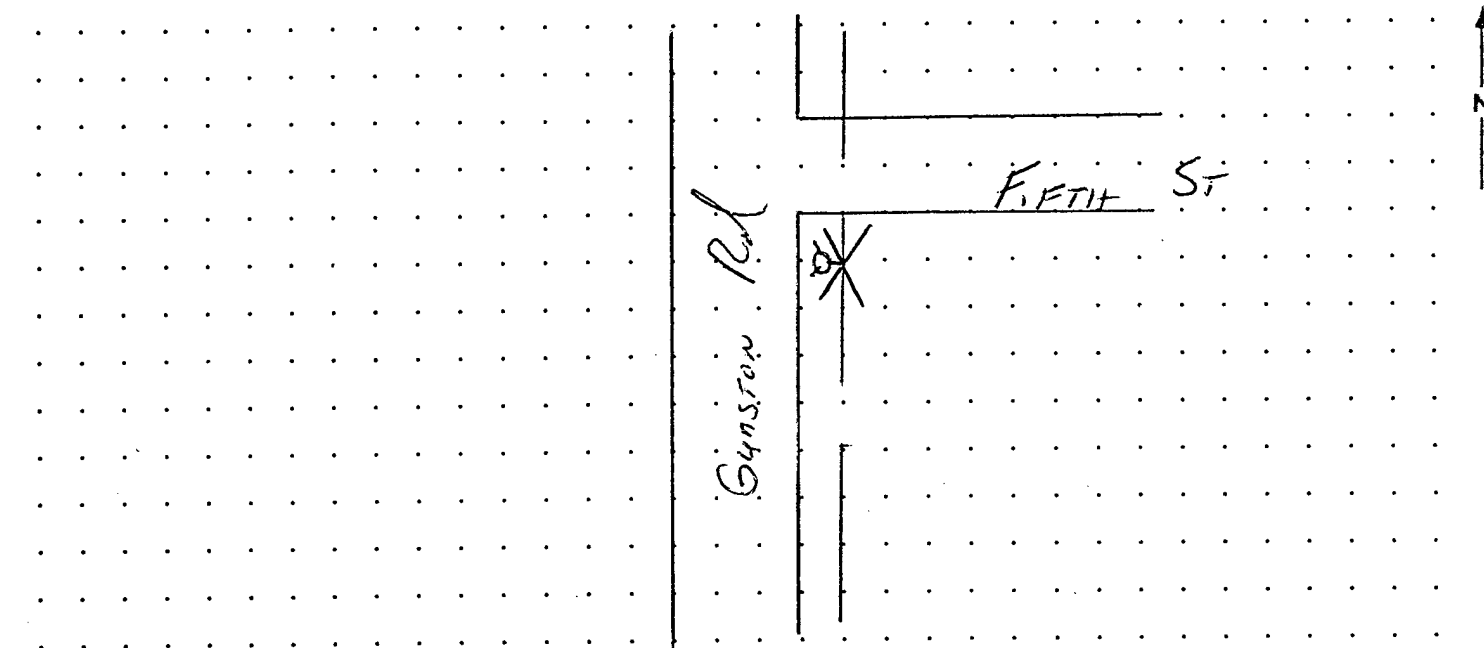
Fire hydrant at intersection of Gunston Rd
& FIFTH ST LEAKING

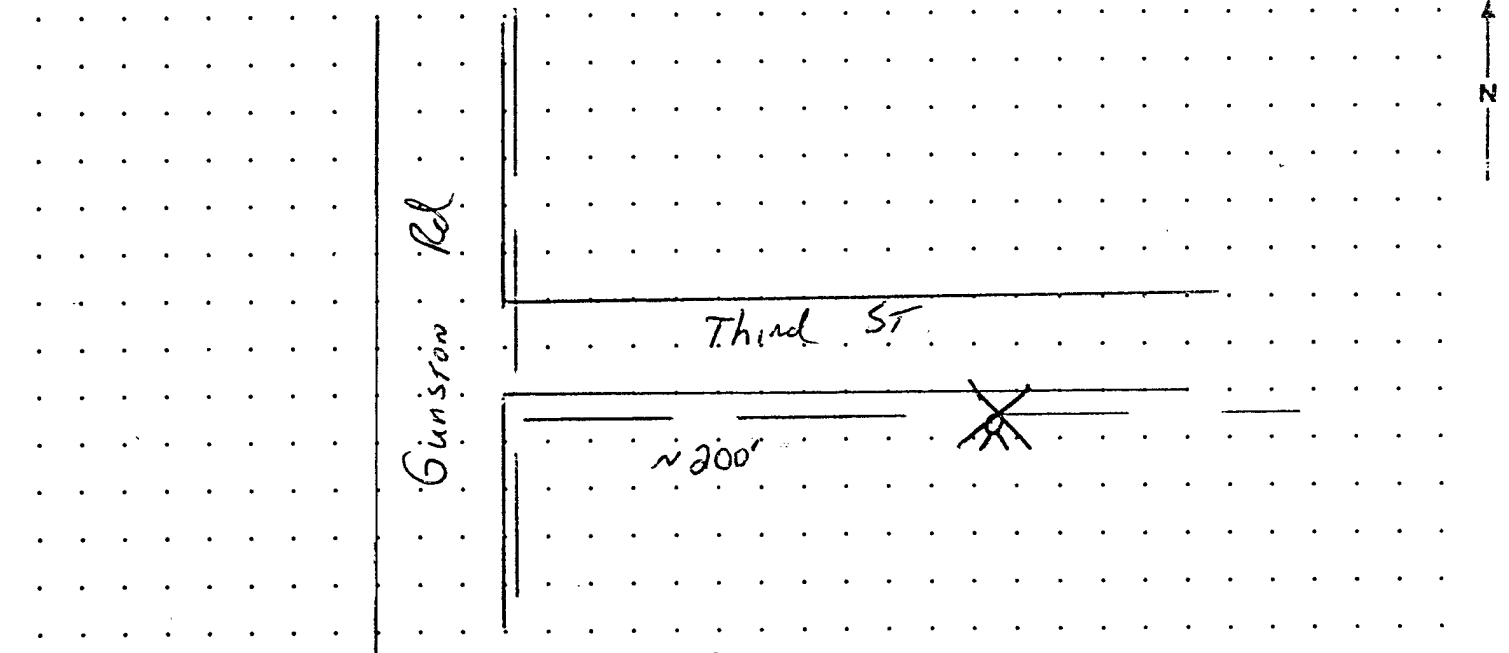
Page No. 6
Date 6-22-95
Ownership Public Private Easement
Leak Indication Classification
1 2 3
(Circle One)

Remarks Fire hydrant on Third St approx 200 FEET
EAST of INT of Third St + Gunston Rd LEAKING

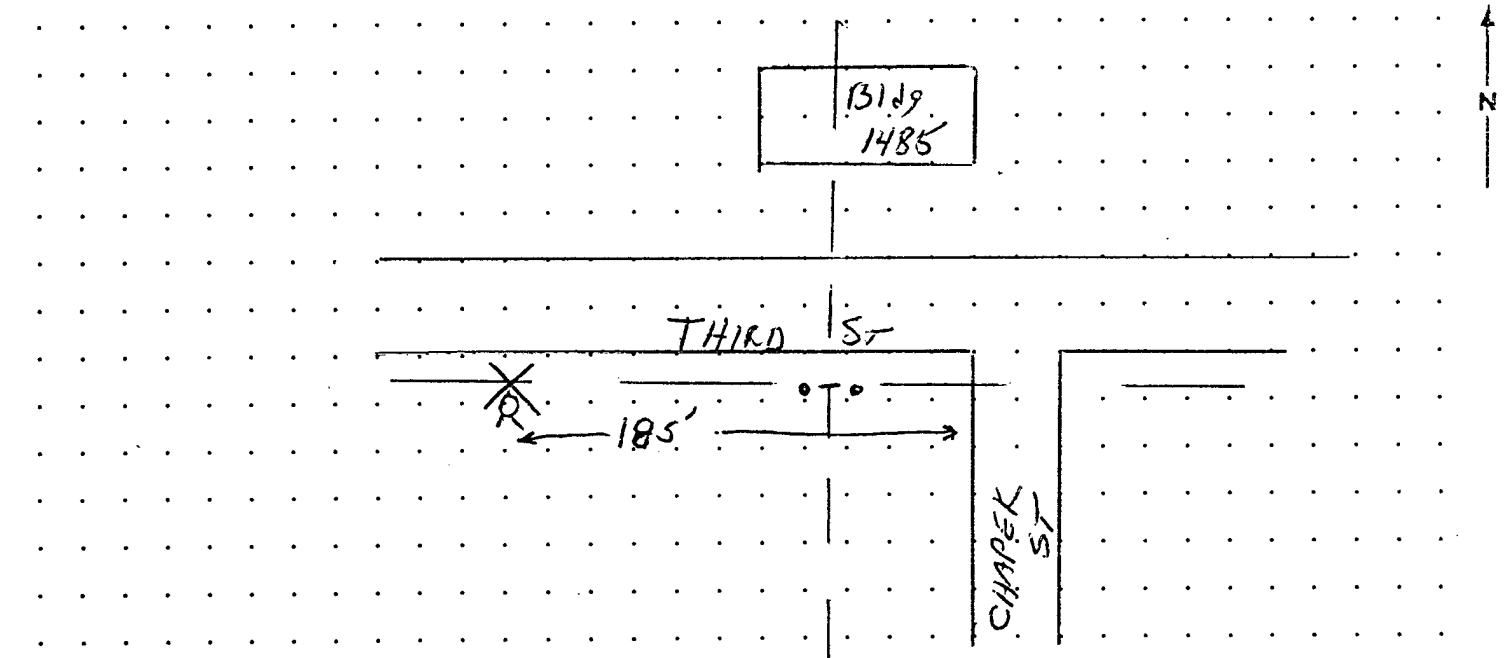
Page No. 7
Date 6-22-95
Ownership Public Private Easement
Leak Indication Classification
1 2 3
(Circle One)

Fire hydrant on Third St approx 185' west
of int of THIRD ST & CHAPEK ST LEAKING

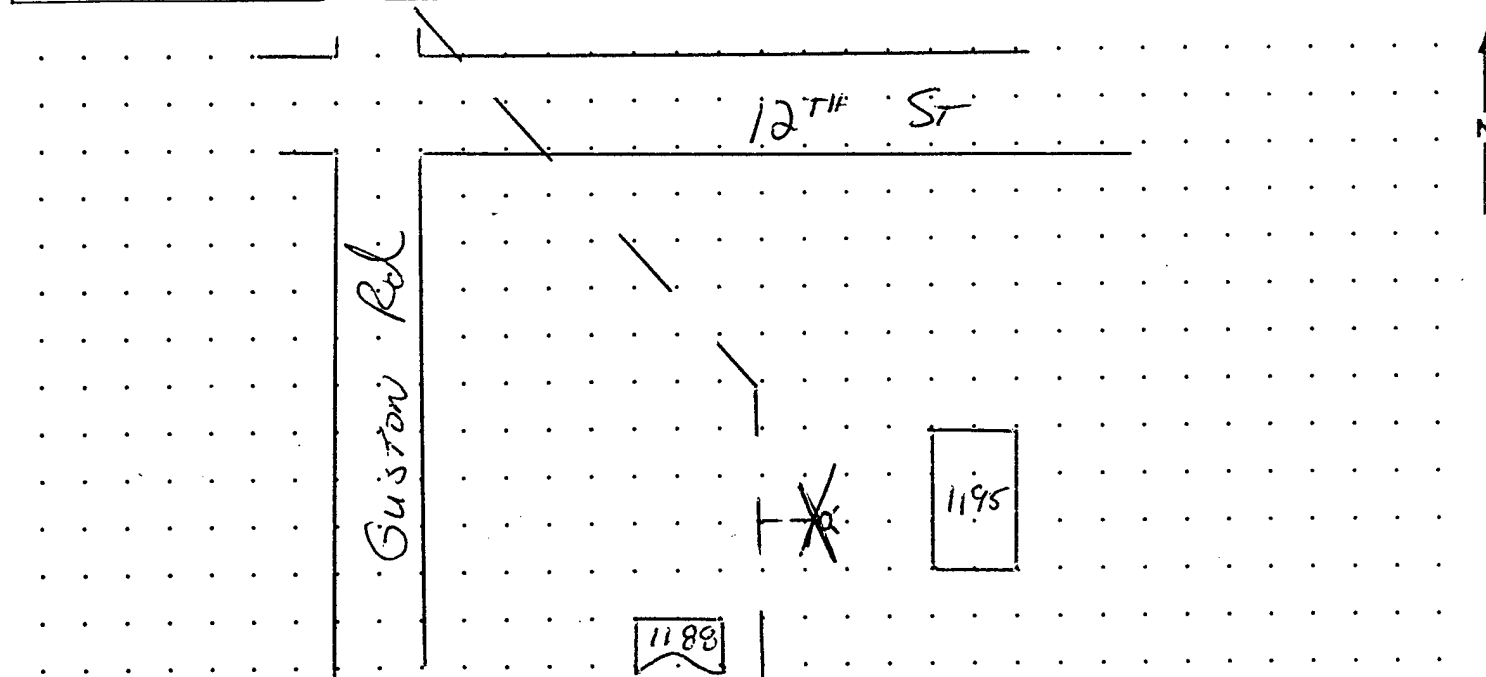
Page No. 8
Date 6-23-95
Ownership Public Private Easement
Leak Indication Classification
1 2 3
(Circle One)

Fire hydrant in grass in front of
Building #1195 leaking

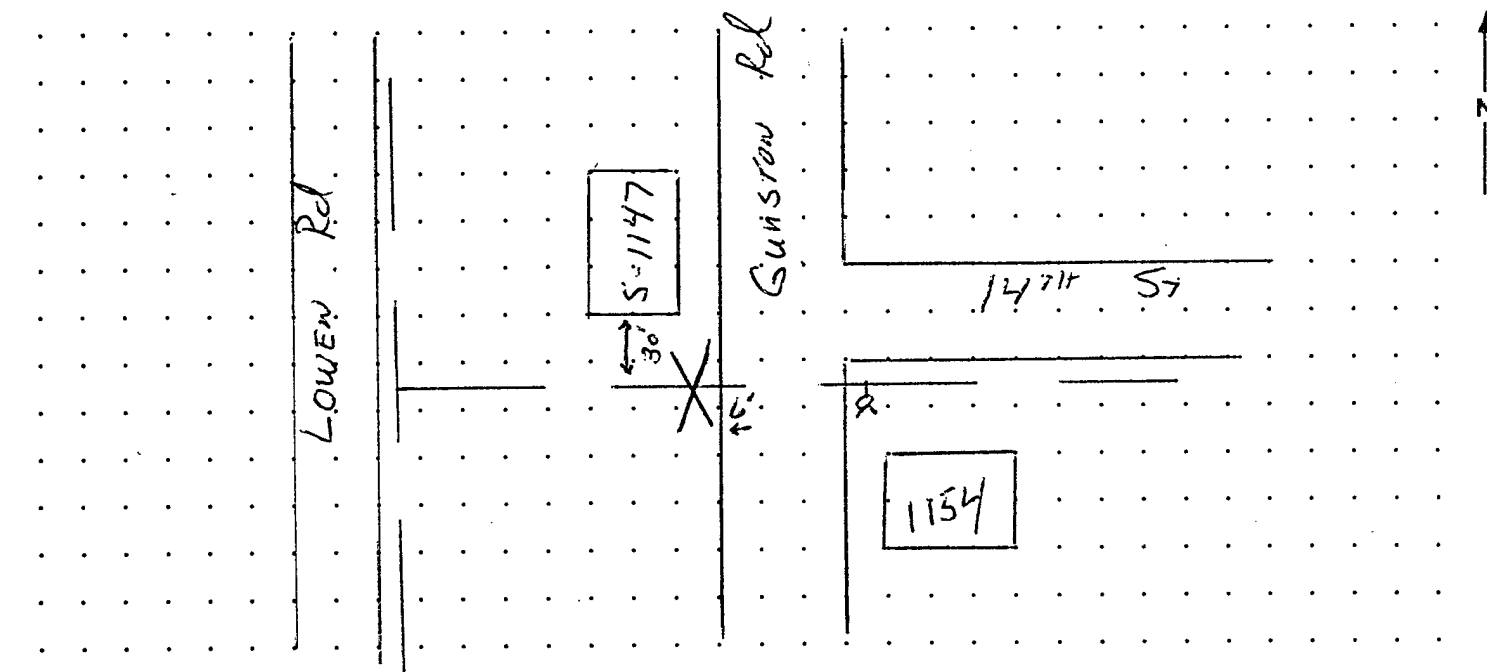
Page No. 9
Date 6-26-85
Ownership Public Private Easement
Leak Indication Classification 2
1 (Circle One) 3

<u>10 gpm</u>

Remarks LEAK on 8" main off 12" main. LEAK is
Behind CURBLINE south of Building # S-1147. LEAK
is approx 30' south of south Building Wall of # S-1147
and approx 10' west of west curb line of Gunston Rd
across Road from int. of Gunston Rd + 14th St

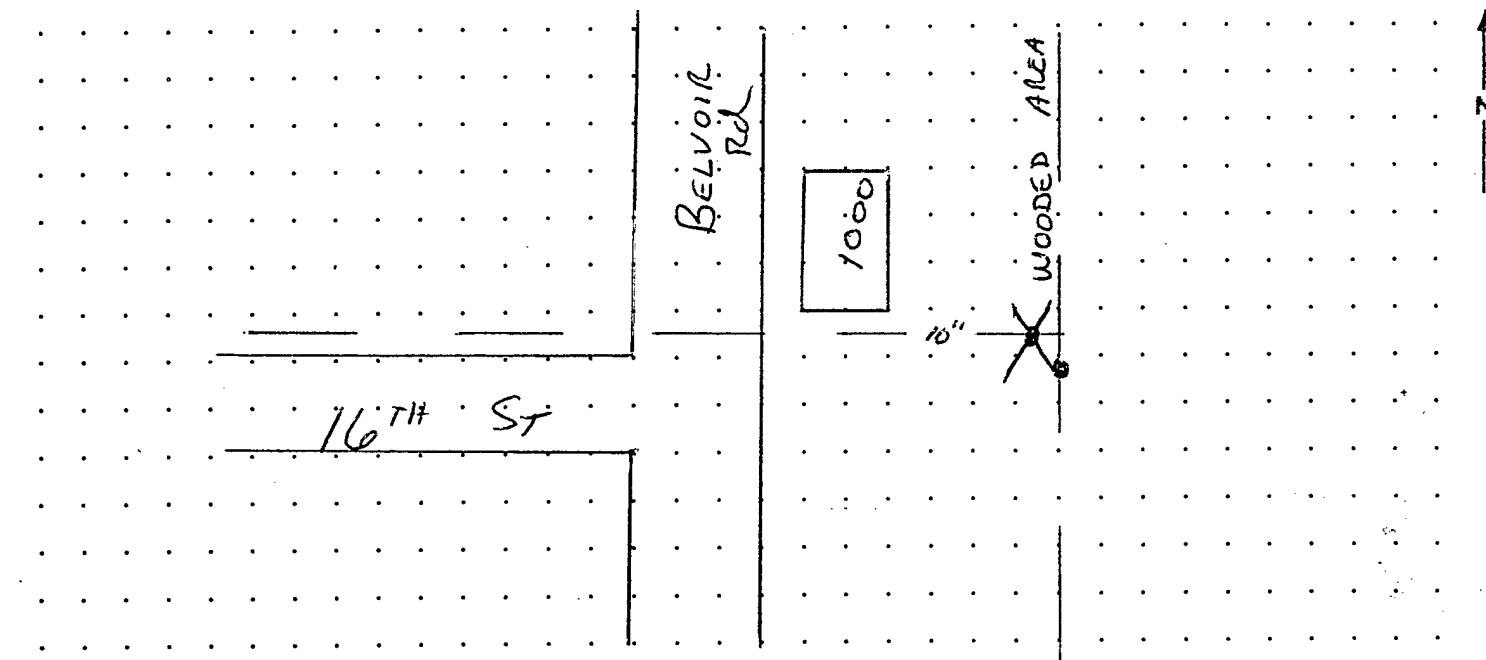
Page No. 10
Date 6-26-95
Ownership Public Private Easement
Leak Indication Classification
1 2 3
(Circle One)

LEAK APPEARS to be on MAIN, AT OR NEAR
VALVE (possible flange) on ~~water~~ line running WEST along
side of Building #1000. LEAK & VALVES ARE IN WOODED AREA
Behind Building #1000.

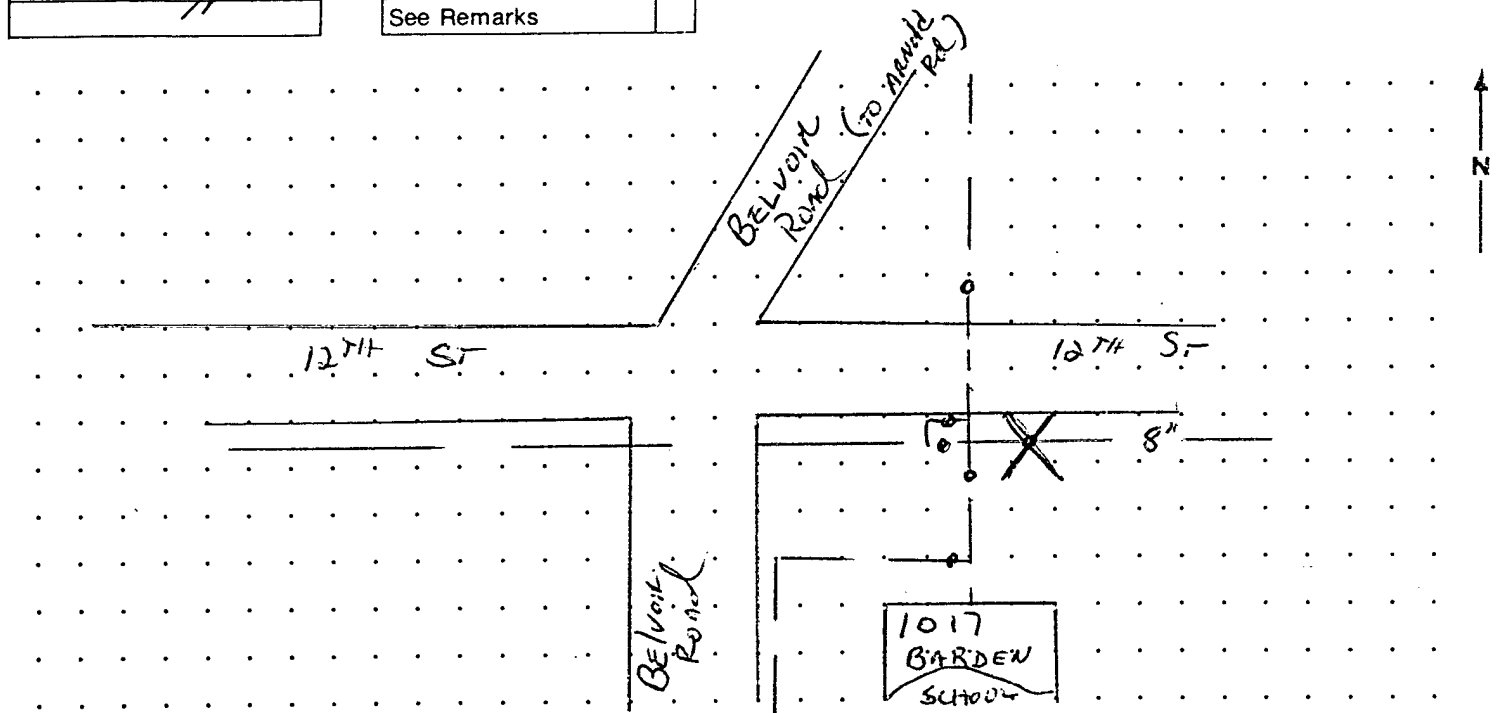
Page No. 11
Date 6-26-95
Ownership Public Private Easement
Leak Indication Classification
1 2 3
(Circle One)

8" valve controlling flow EAST on 12th ST
from valve group along 12th ST in front of #1017
(BARDEN School) leaking - WATER SURFACING

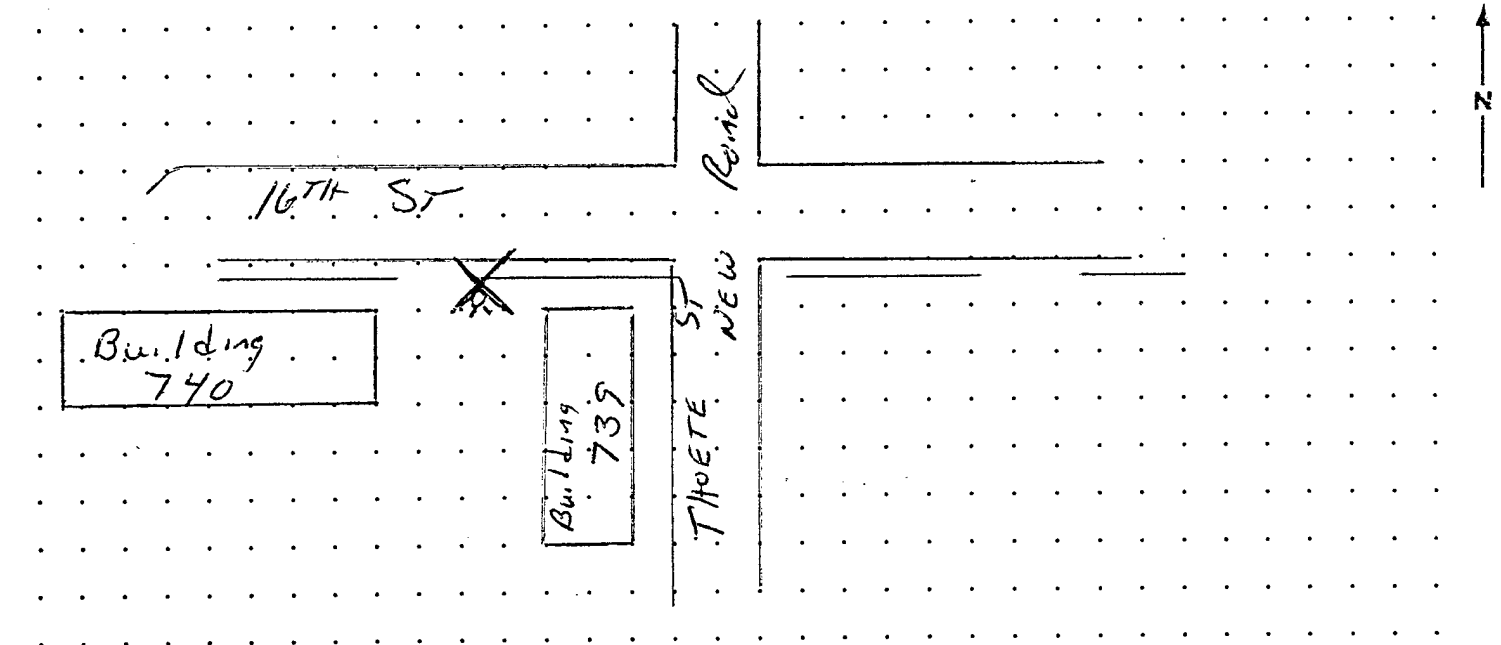
Page No. 16
Date 6-28-85
Ownership Public Private Easement
Leak Indication Classification
1 2 3
(Circle One)

LEAK APPEARS to be AT FIRE hydrant, possibly had
LATERAL AT FIRE hyd on 16TH ST Between Buildings # 739
& 740

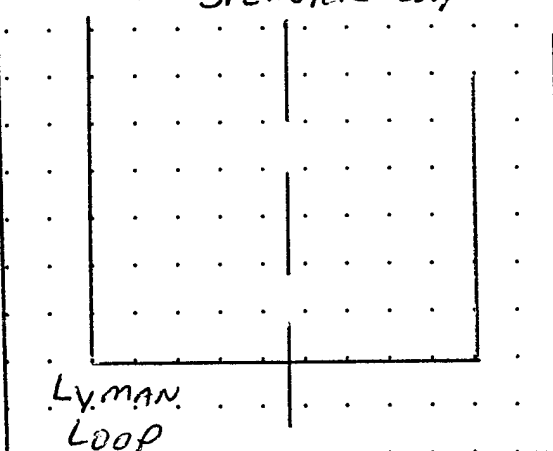
<u>15 gpm</u>

Fire hydrant Body at FIRE hydrant on
Back side of Lyman Loop cracked - Fire hydrant
has 1 1/2" crack in Body

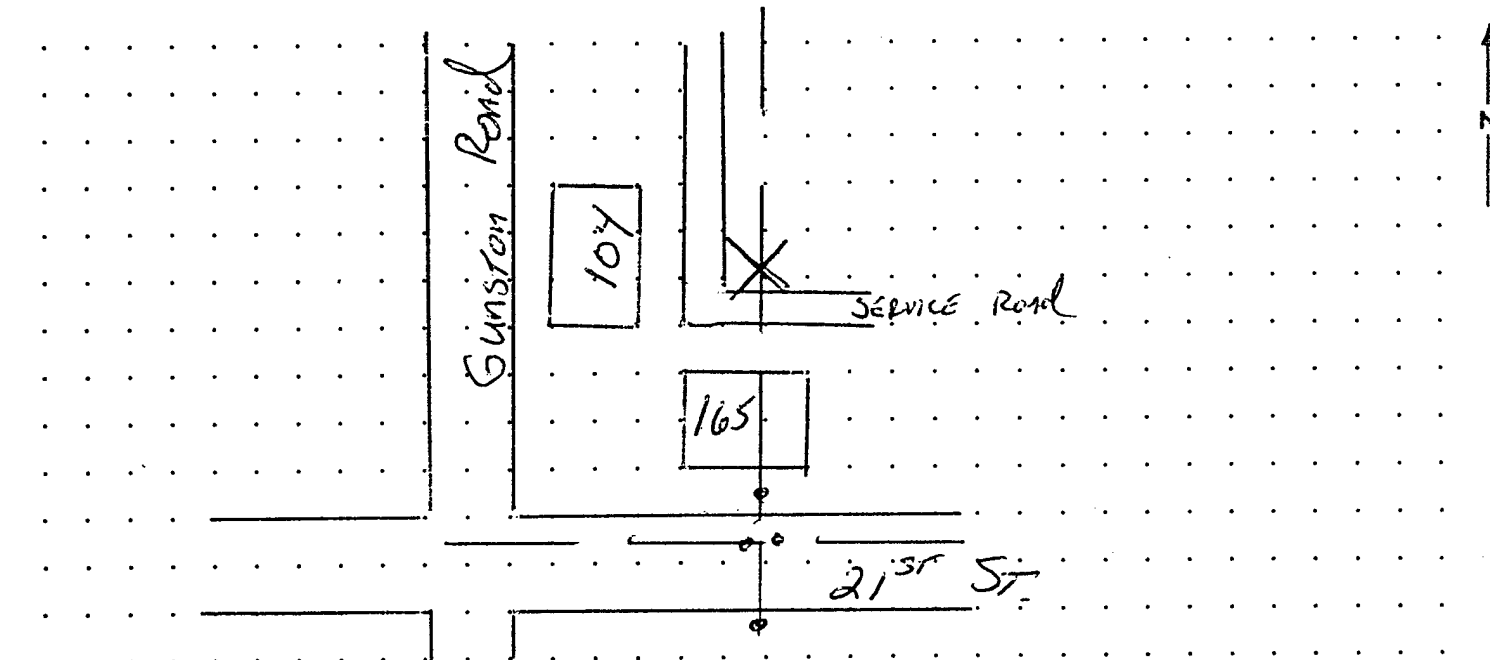
<u>20 gpm</u>

LEAK APPEARS to be on MAIN along north
SIDE of SERVICE ROAD behind #165 21ST ST

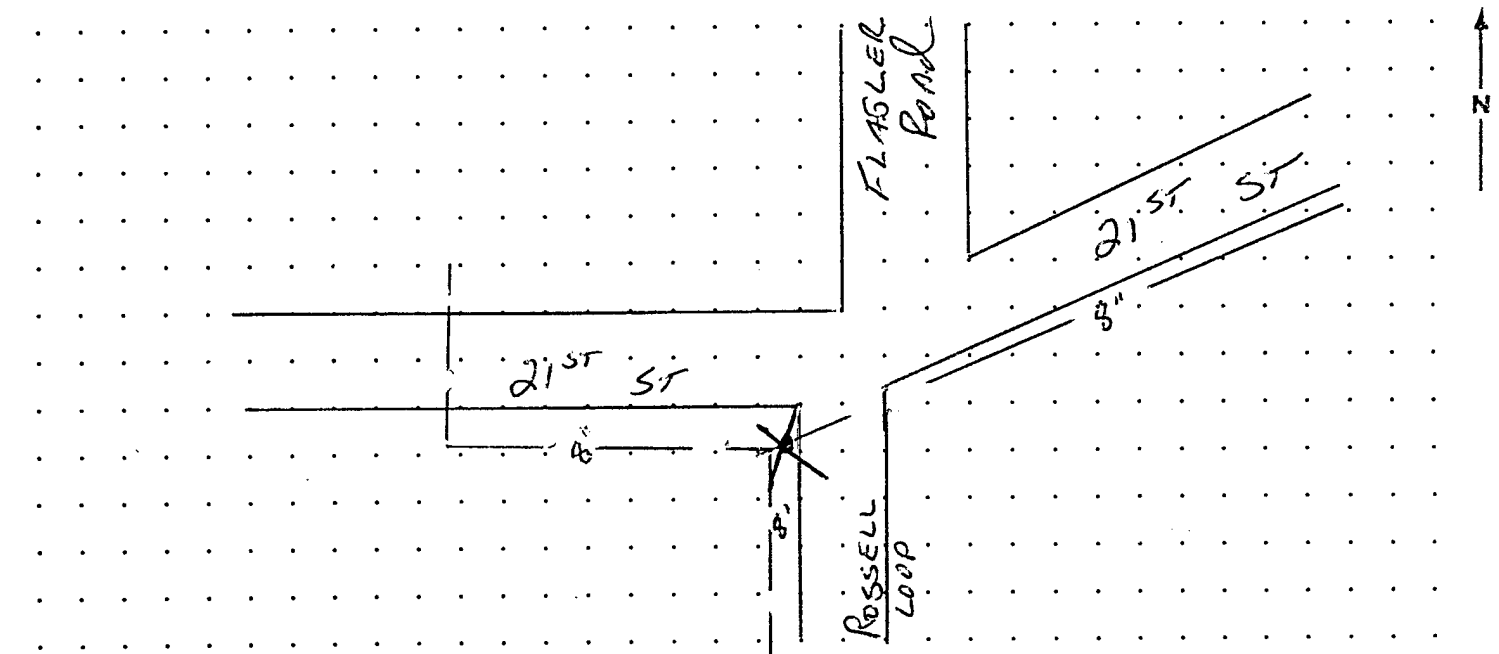
Page No. 21
Date 7-11-95
Ownership Public Private Easement
Leak Indication Classification
1 2 3
(Circle One)

8" MAIN VALVE AT SE. CORNER of int of
ROSELL Loop & 21ST ST. WATER SURFACING

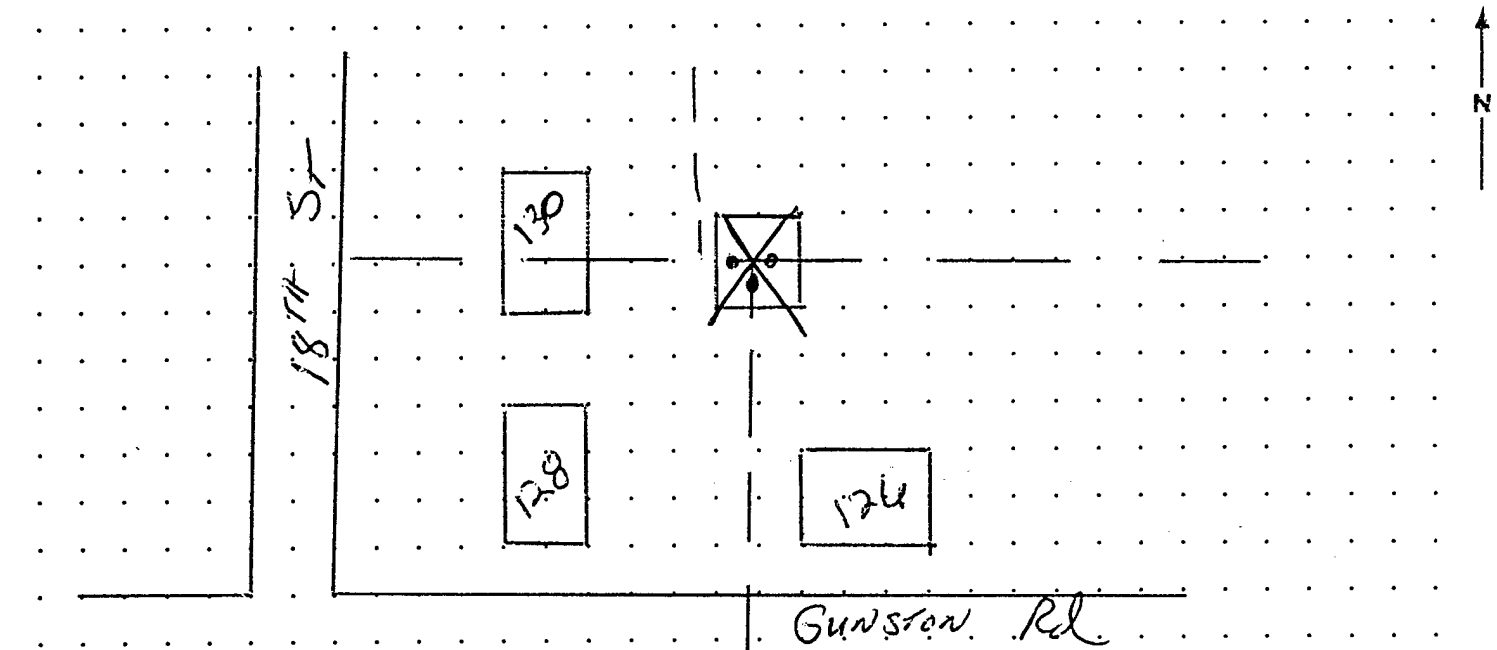
Page No. 22
Date 7-11-95
Ownership Public Private Easement
Leak Indication Classification
1 2 3
(Circle One)

Remarks LEAK appears to be on valve in value pit at
REAR of #130 18TH ST. Pit is full of water
so exactly which valve is leaking cannot be determined

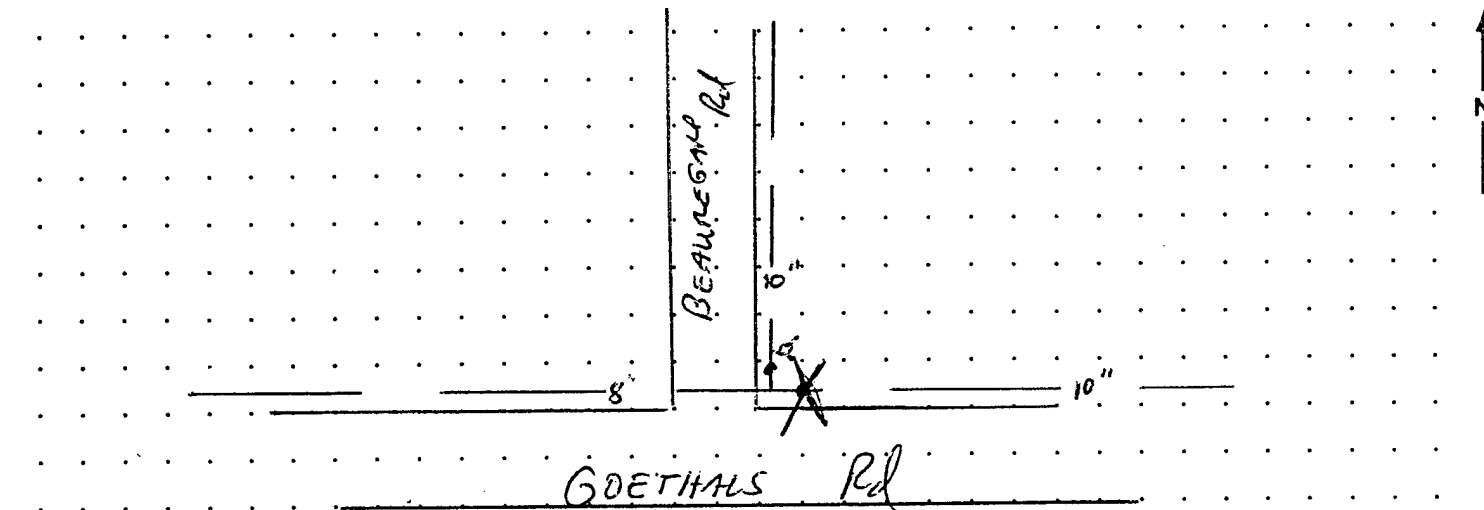
10" MAIN VALVE controlling water flow EAST
ON GOETHALS Road FROM INT WITH BEAUREGARD Rd
leaking

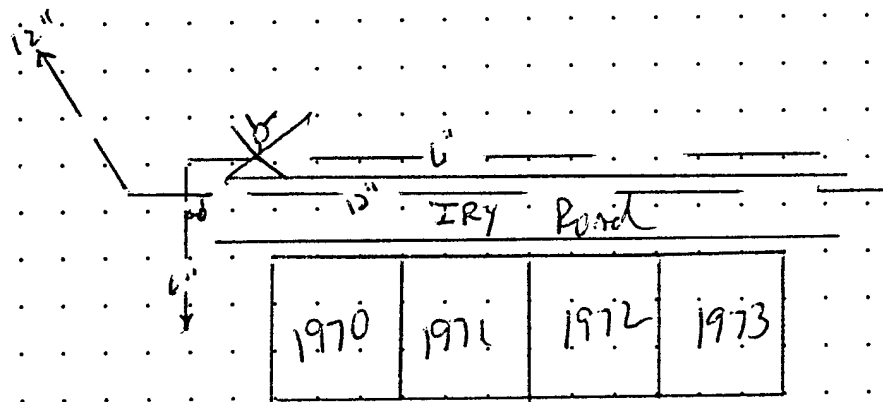
Page No. 24
Date 7-13-95
Ownership Public Private Easement
Leak Indication Classification
1 2 3
(Circle One)

Fire hydrant AT REAR of #1970 IRY Road
LEAKING

A POSSIBLE SECOND LEAK HERE - maybe 12" x 6"
REAR TIE IN. TOO MUCH MUD, WATER & CAT TAILS
TO LOCATE EXACT SOURCE of surfacing
water

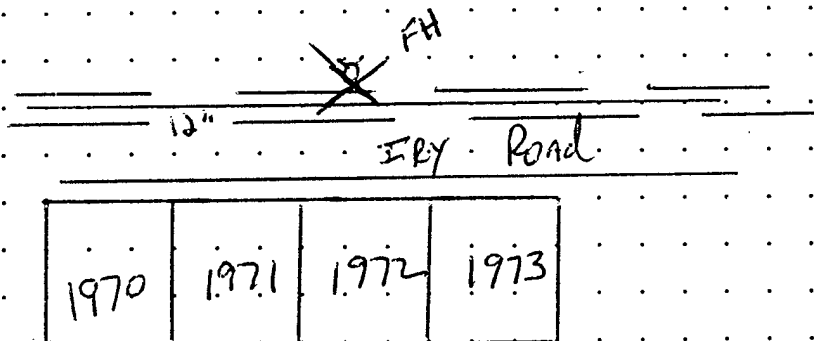
Page No. 25
Date 7-13-87
Ownership Public Private Easement
Leak Indication Classification
1 2 3
(Circle One)

Fire hydrant across ERY Road from Building #1972
leaking

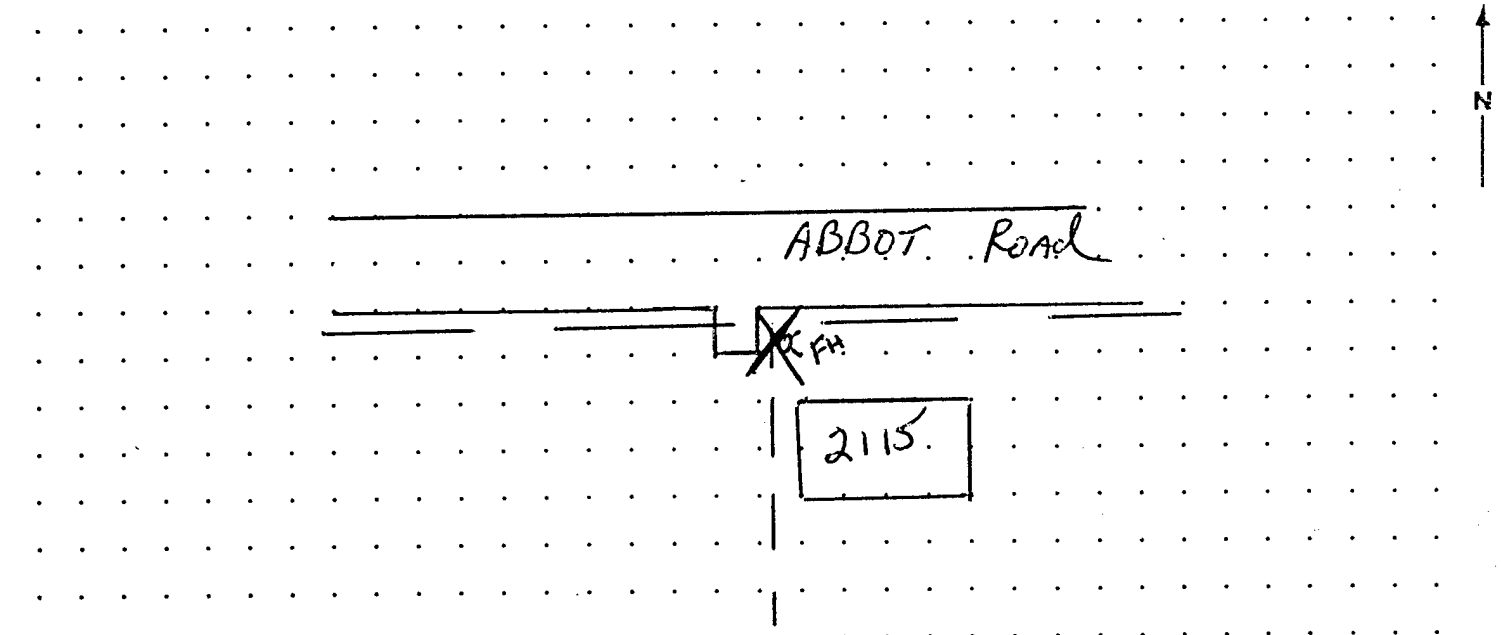
Page No. 26
Date 7-13-95
Ownership Public Private Easement
Leak Indication Classification
1 2 3
(Circle One)

Remarks Fine hydrant AT N.W corner of Building
2115 (NORTH HEALTH CLINIC) on ABBOT Road leaking

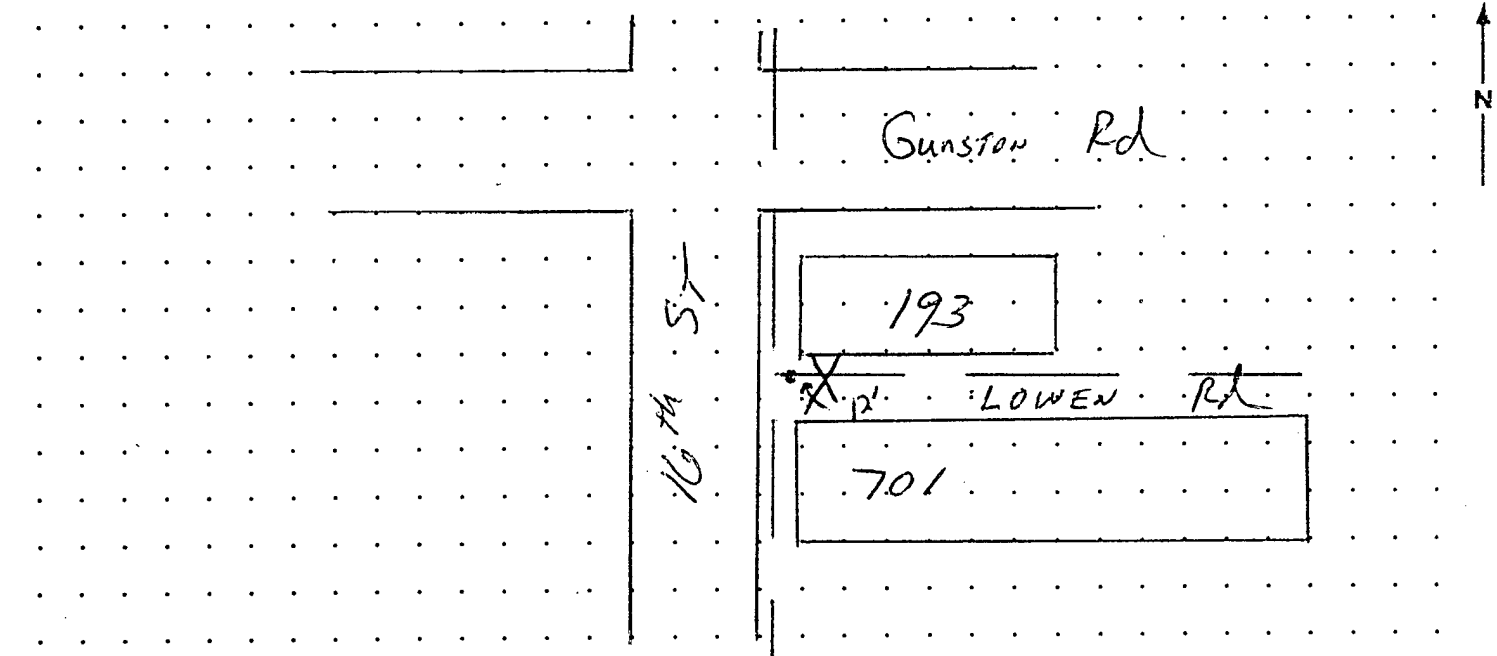
Page No. 27
Date 7-14-95
Ownership Public Private Easement
Leak Indication Classification
1 2 3
(Circle One)

LEAK APPEARS to be on 6" MAIN RUNNING
EAST FROM 16th St Between Buildings # 193 & 701.
LEAK IS APPROX 12' EAST OF 6" MAIN VALVE AT INT
OF 16th St & Access Road Between Buildings (LOWEN Rd)
193 & 701

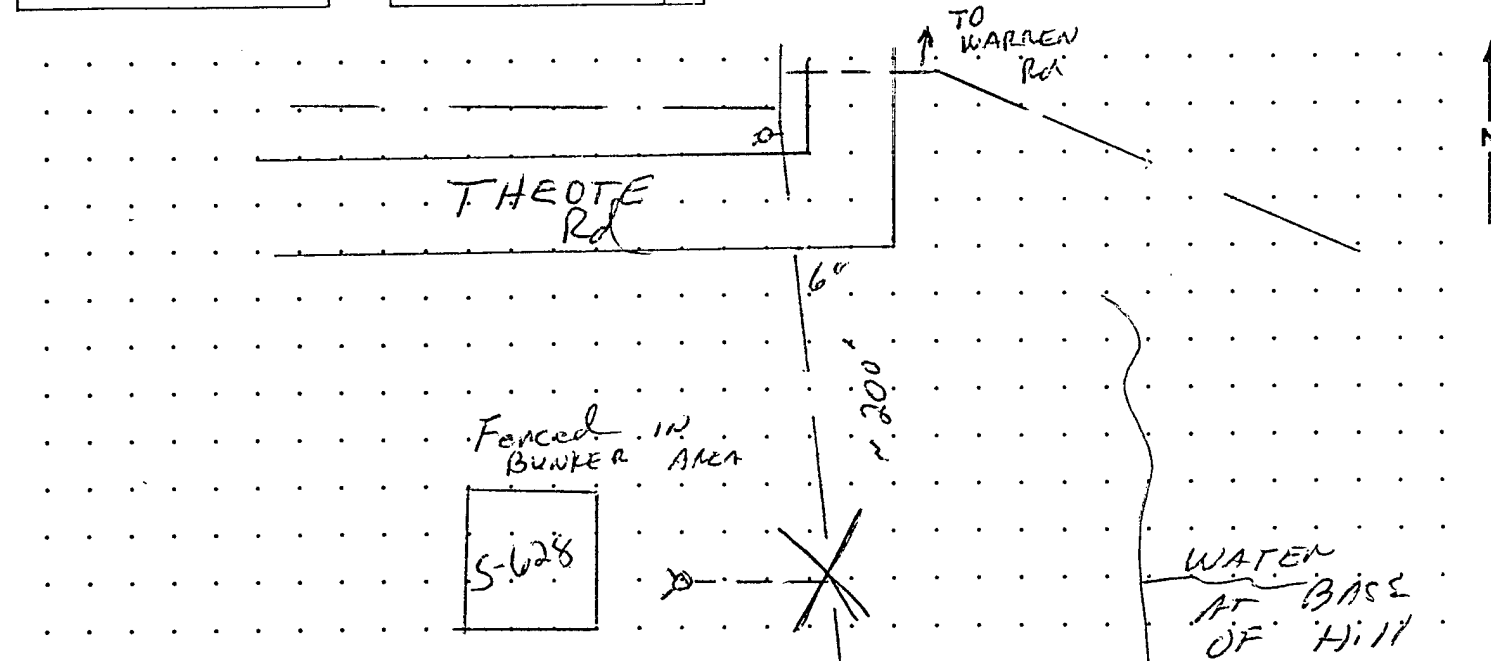
Page No. 28
Date 7-14-95
Ownership Public Private Easement
Leak Indication Classification
1 2 3
(Circle One)

LEAK APPEARS to be on 6" MAIN IN
right of way off of THEOTE ROAD. LEAK IS IN
AREA of FIRE hydrant "T" NEAR BUILDING S-628

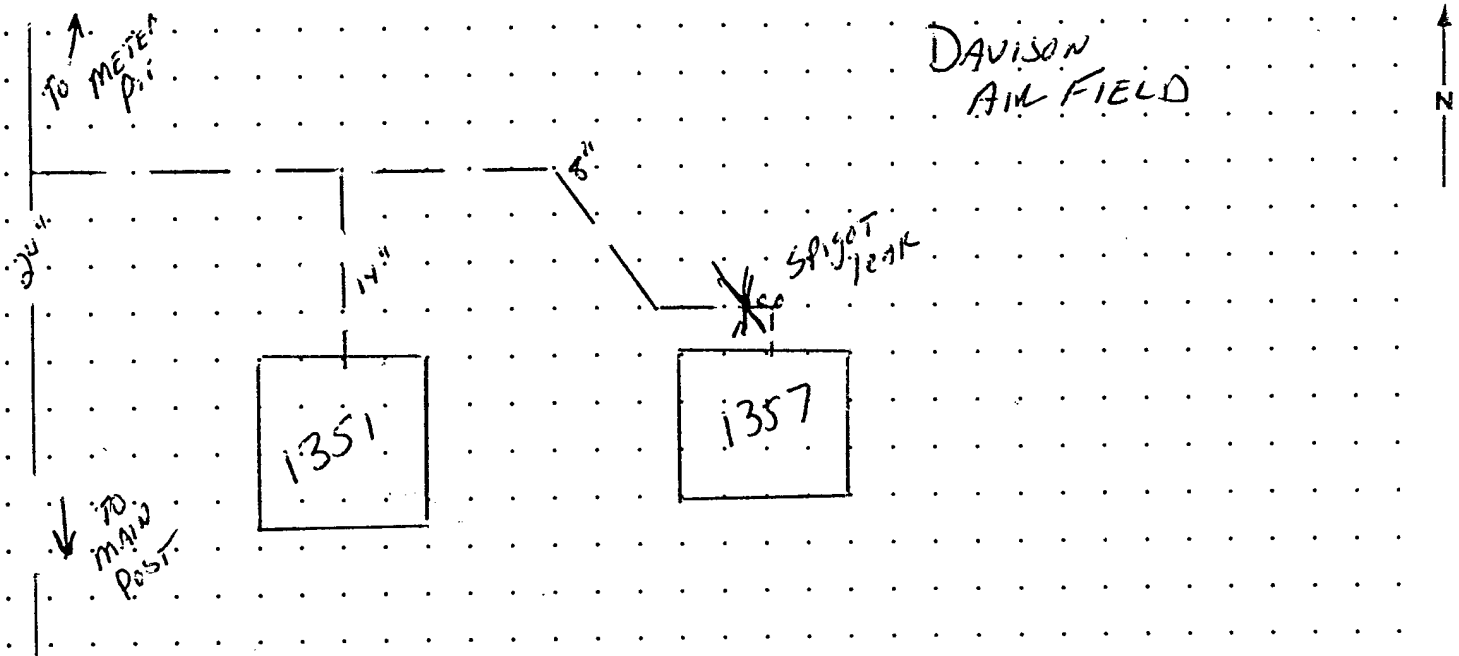
Page No. 30
Date 7-17-95
Ownership Public Private Easement
Leak Indication Classification
1 2 3
(Circle One)

<u>1 gpm</u>

Remarks OUTSIDE YARD SPIGOT LEAKING AT BASE
WATER SURFACING

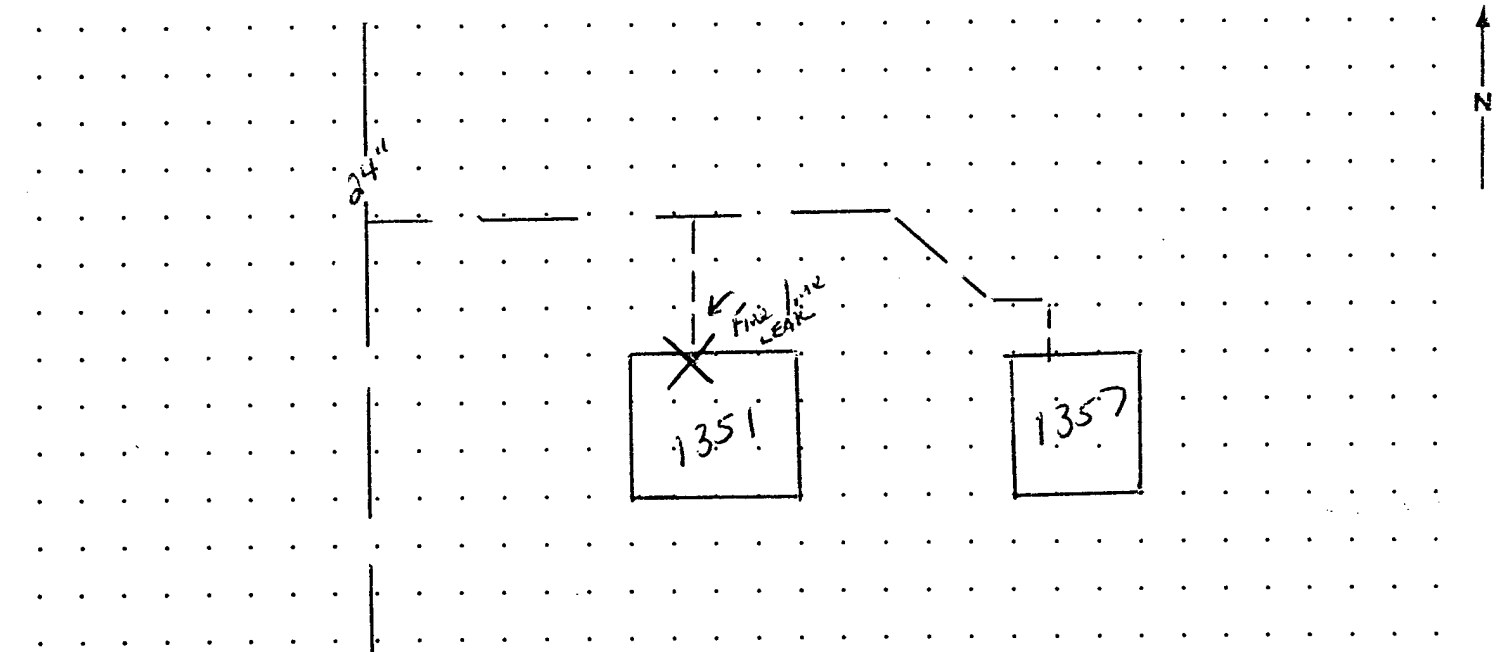
Page No. 31
Date 7-17-95
Ownership Public Private Easement
Leak Indication Classification
1 2 3
(Circle One)

Check valve on sprinkler line in Building
1351 leaking through drain line. Water coming out
drain line outside building
